To commemorate the Founding of the Institution of Civil Engineers in the UK,
200 Years Ago

A Short Presentation, dated April 11th 2018

“The Frank Slide”

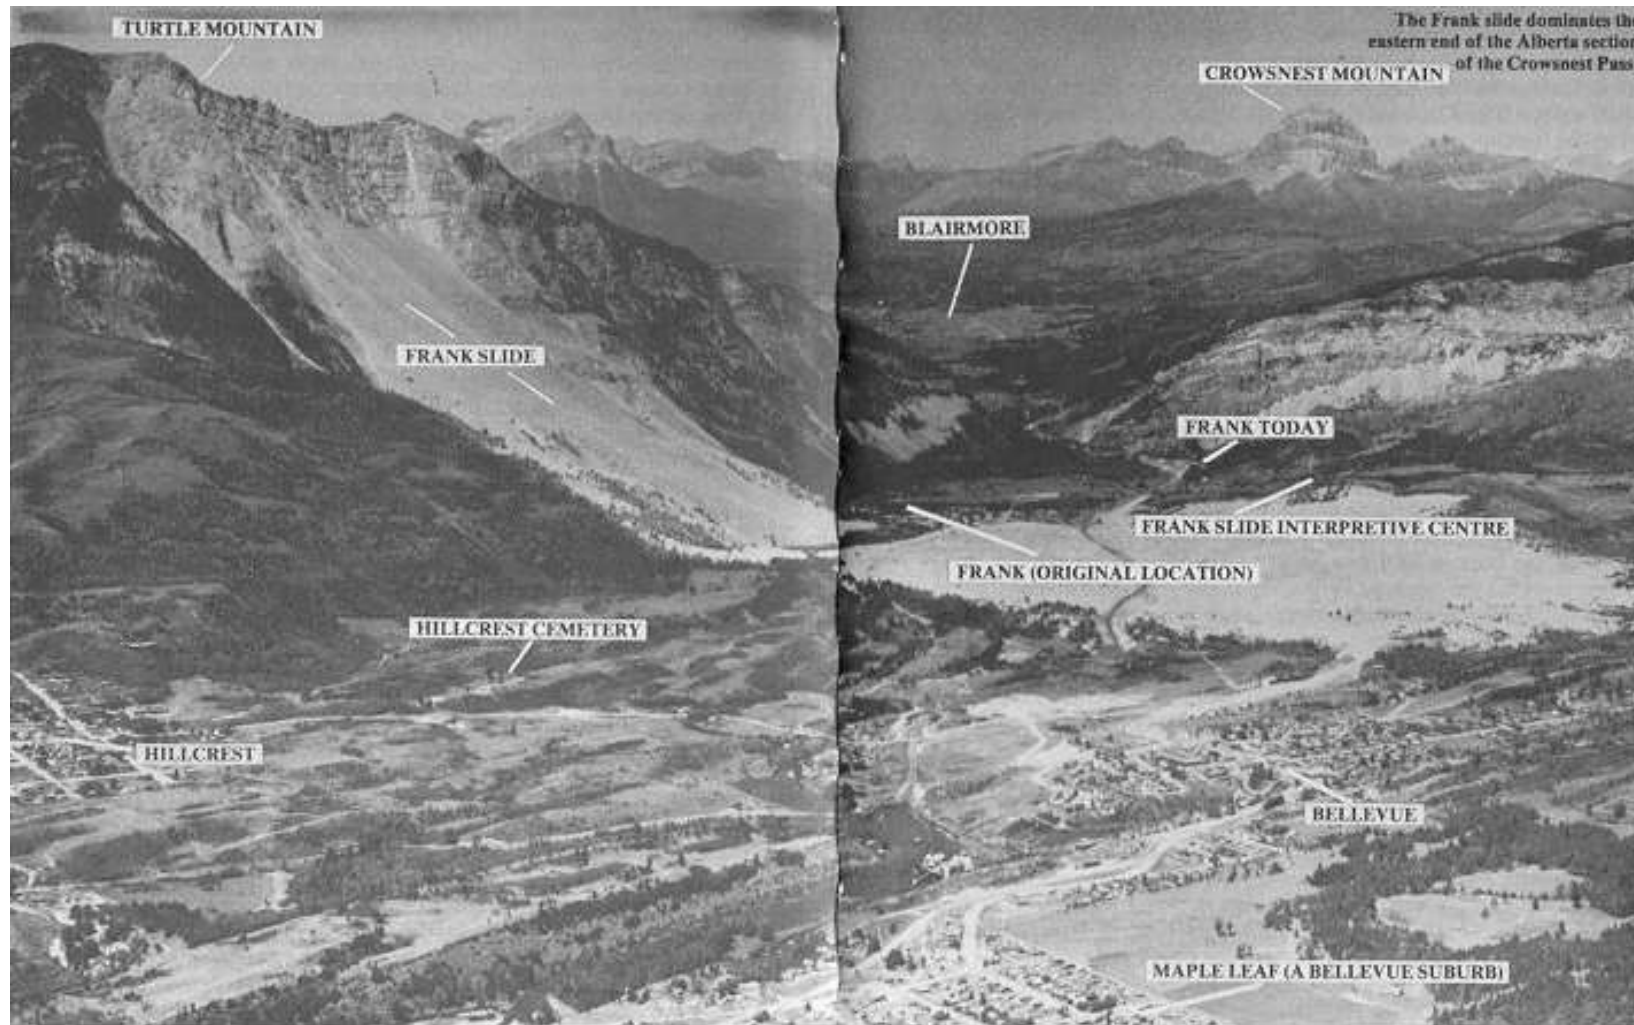
Side View – east flank of Turtle Mountain

- ❑ A rockslide occurred early in the morning at 4:10 am, April 29, 1903
- ❑ Some 82,000,000 tonnes of massive limestone boulders tumbled down Turtle Mountain into the River Valley below
- ❑ The speed of the rockflow was estimated at around 120 km/h
- ❑ Rock debris fanned out and covered 3 km² of the valley to an average depth of 14 m; with some spot as deep as 45m.

- ❑ **Glaciers** came down the valley and shaved off Turtle Mountain's eastern flank making it even steeper. When glacier retreated the fractures opened wider. Cliffs were left "hanging" unsupported high above the valley.
- ❑ **Miners** reported hearing strange noises inside the mine. Props & timber supports began splintering. Coal fell from roof and walls to the mine floor. These signs indicated the mountain was shifting. Three years into mining, Turtle Mountain collapsed.

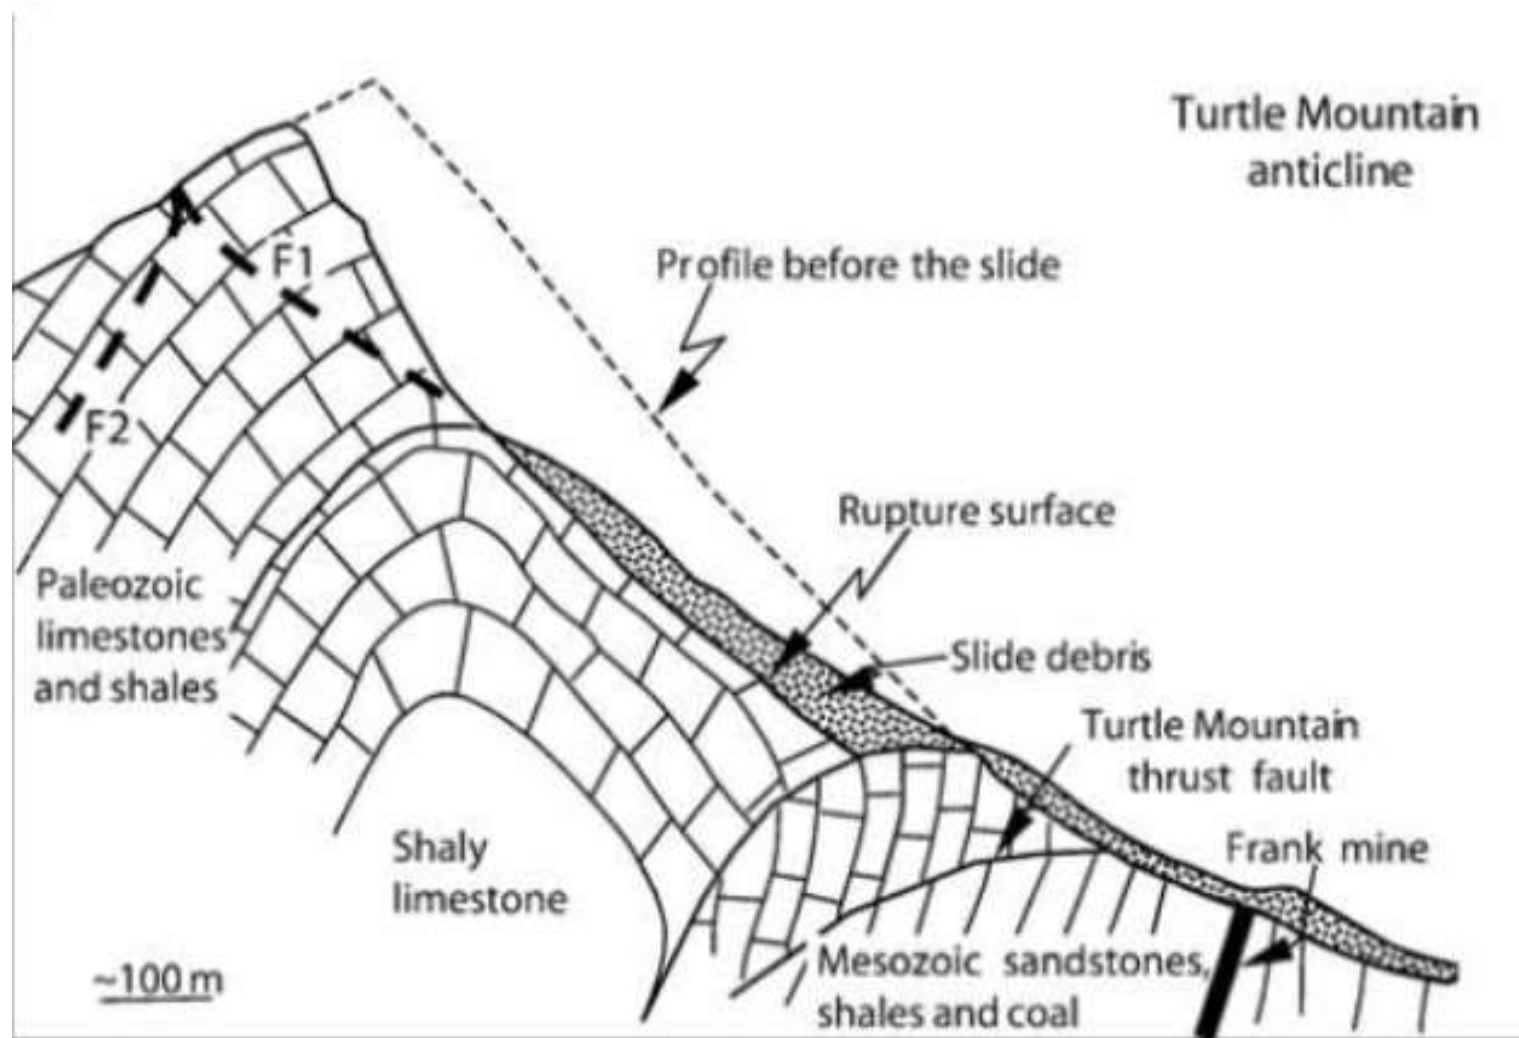
Cross Section of Turtle Mountain Anticline

- ❑ **Geological movements** folded limestone, sandstone, siltstone and shale beds into Turtle Mountain Anticline. Rock openings were formed.
- ❑ **Erosion** dissolved these openings wider to allow more seepage water into the mountain core forming caves, cavities and springs.

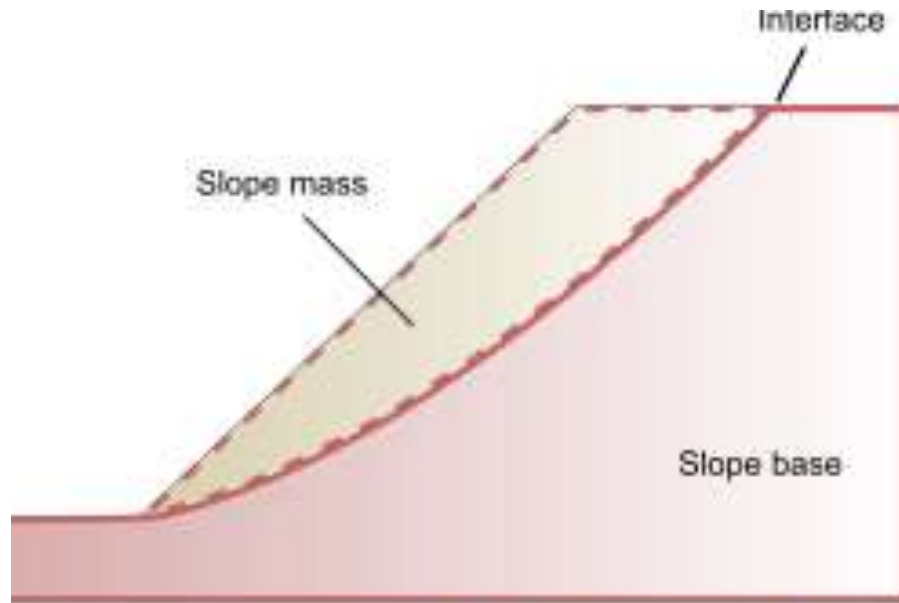
Simulation of Landslide in Studies

A typical cross-section of a slope used in two-dimensional analyses.

- ❑ As you can see from the foregoing rockslides and indeed all forms of slides are very destructive
- ❑ Civil Engineers have long been conducting intensive research to mitigate this problem because it has been, and still is, a great social and economic issue
- ❑ Engineers have simulated the failure mechanisms within the slopes and employed mathematical tools to describe these failures
- ❑ Such work continues today
- ❑ The Frank Slide has contributed much towards the studies of the subject of Slope Stability Analysis

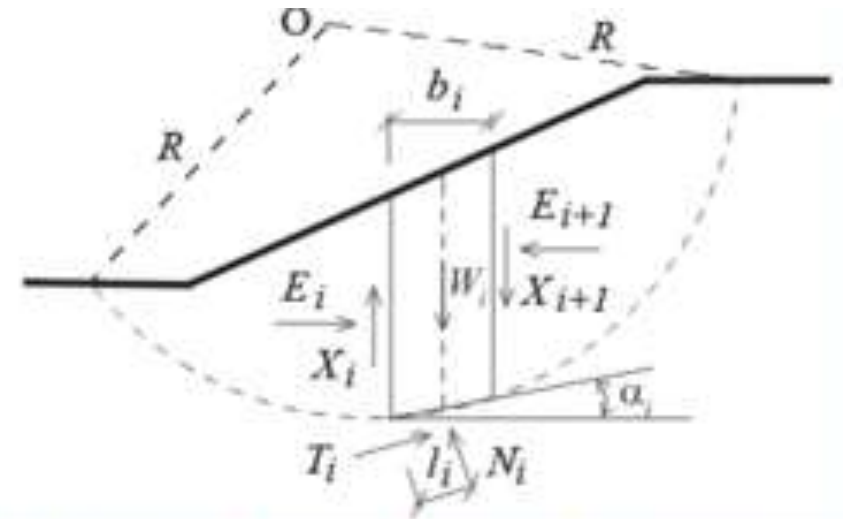
Schematic of the method of slices showing rotation center.
